Type 26 Register Update No. 10

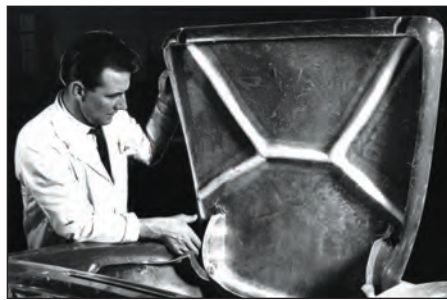
RARE PHOTOGRAPHS TAKEN IN MID-1963 AT BOURNE PLASTICS NOTTINGHAM, SHOWING THE CHARACTERISTIC RIBBED FLOOR OF BODY NUMBER 158 (NOT KNOWN TO THE REGISTER) AND THE LAYOUT OF THE SOMRIB PAPER ROPE, USED TO STIFFEN THE BONNET, BUT ALSO USED UNDER THE NOSE.
