Type 26 Register Update No. 10

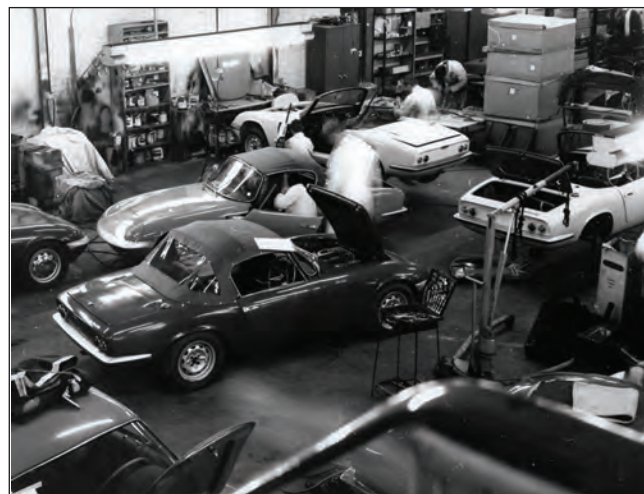
S1 PRODUCTION AT CHESHUNT. QUIZ: WHEN WAS THIS PHOTO TAKEN? (MONTH AND YEAR PLEASE!) THE CLUES ARE IN THE PICTURE! PLEASE EMAIL charles@type26register.com WITH AS MANY REASONS AS POSSIBLE TO SUPPORT YOUR ANSWER, AND I WILL PUBLISH THE RESPONDENTS, WITH THEIR CORRECT REASONING, IN THE NEXT UPDATE. THE FULLEST ANSWER WINS A PRIZE. PLEASE VISIT WWW.TYPE26REGISTER.COM TO SEE THE IMAGE IN THE ORIGINALITY SECTION. TIP: YOU MIGHT LIKE TO USE THE ZOOM FUNCTION TO GET THE KEY INFORMATION NECESSARY!"
